QUINEBAUG RIVER BASIN  
SOUTHBRIDGE, MASSACHUSETTS

COHASSE BROOK RESERVOIR DAM  
MA 00694

**PHASE I INSPECTION REPORT  
NATIONAL DAM INSPECTION PROGRAM**

APRIL 1979

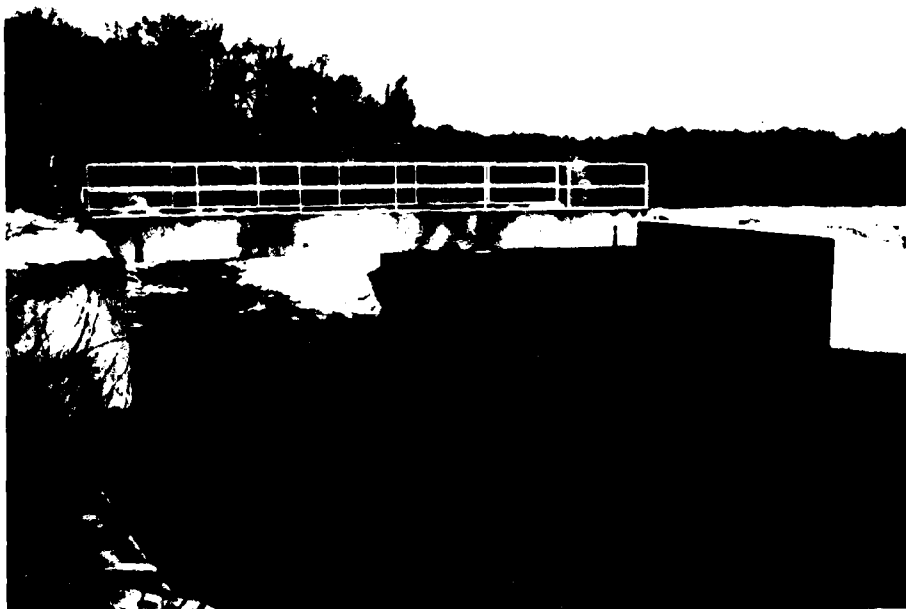
NO. 1 VIEW OF SPILLWAY
